ADDRESS
XXXXX
XXX
XX

BUILDING SURVEY REPORT

Property address	XXXXXXXXXXXXXXXXXXXXXXXXXXXX
Property type	A two storey period detached house.
Year built	Circa 1750 and converted circa 1990.
Accommodation	Ground floor: Living Room, Dining Room, Kitchen, Utility Room, Study. First floor: Three Bedrooms, Two Bathrooms. Outbuildings: There is an open sided car port. External: There are gardens to the rear and side.
Location	The property is situated in an attractive village location with limited amenities in the immediate vicinity. Further amenities can be found in both Southwell and Newark.
The Site and Surrounding Area	The property is located on a relatively flat plot.
Tenure	It has been assumed that the property is being sold on a freehold basis with vacant possession on completion of sale.
Floor area	180 m2.
Insurance reinstatement cost	£240,000

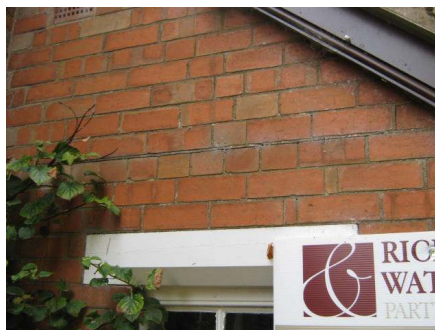
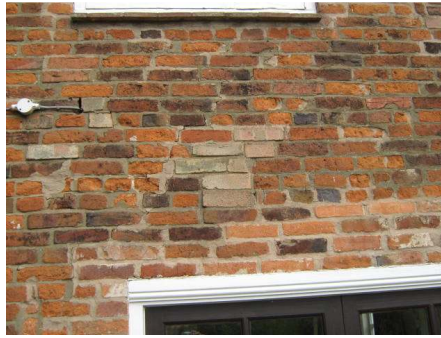
Localised cracking and distortion of brickwork is evident around the right side living room doors and over the left side utility room window. This is a common fault with older properties of this age and type where the structure has settled slightly over the years. This is not thought to have any serious structural significance. Minor repairs of the brickwork will be required. You may find that the cracks re-open slightly over the years. There has been some re pointing over the living room doors and you should ask the owners whether they have installed a lintel. If not, one should be installed.

We noted some cracking above the right side patio doors. This type of cracking is normally related to a lack of sufficient support over the door openings. However it appears that some work has been undertaken over this doorway previously and there may well now be a suitable lintel here. You should make enquiries of the owner in this regard. The cracks over this doorway should be repointed.

We noted a horizontal mortar bed crack to the left side of the front single storey section above the utility room window. This is typical of settlement type cracking and should be infilled. Please see our earlier photos.

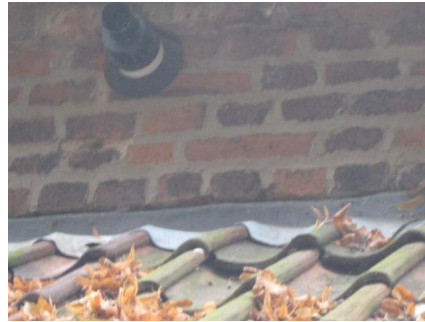
The lead flashing (lead strip over the single storey front roof) needs to be pointed into position to prevent leakages.

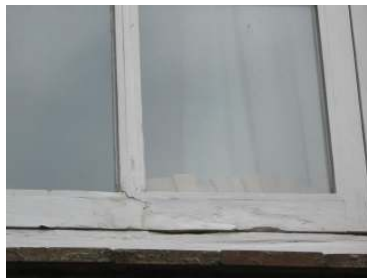
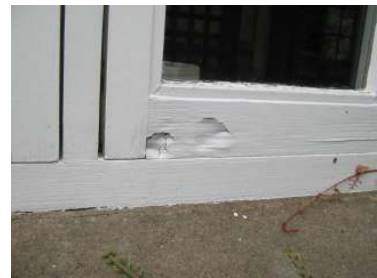
The windows and doors are of predominantly timber construction and appear to be in a generally serviceable condition. There are however some pockets of wet rot noted to the rear living room windows, to the study window and to the living room doorframe. It is thought that these can be infilled and redecorated therefore prolonging their life. The right side window to the main bedroom is however very rotten and this window and frame will now need to be replaced. We estimate that this will cost around £400.

We noted evidence of wet rot to some the windows and door frames around the property and we refer you to our earlier comments.

ACTION: Replace the bedroom window and repair rotten sections.

ACTION: Repair and replace defective windows and door frames.

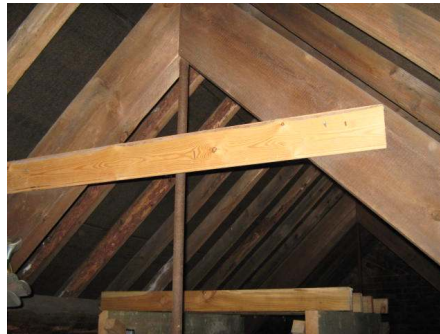
The roof structure is of traditional timber construction with additional steel beams which appears to be adequately supporting the weight of the roof covering. There was no evidence of significant distortion in the roof timbers. No comment can be made, however, on the concealed roof timbers. It is possible that these may have suffered decay such as may be caused by an outbreak of dry rot or wet rot, or been weakened from attack by wood-boring beetles. Concealed timbers include the bottom ends of rafters, wall plates and purlin ends. Although the chances of hidden defect do exist, no obvious signs of significant defect were noted in the accessible areas.

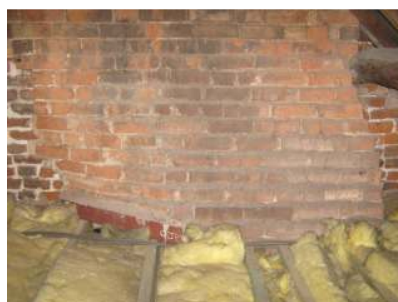
The accessible parts of the fireplaces and chimney breasts appear to be in a satisfactory condition with no sign of significant defect. Part of the living room chimney breast has been removed but this is adequately supported in the roof space on a steel beam.

Steel beam supporting chimney breast in loft

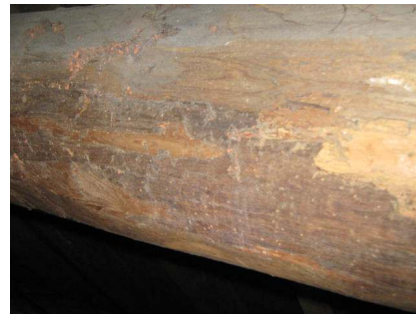
We found evidence of woodboring beetles to the timbers within the roof space. This appears to be largely inactive but you should enquire as to whether these timbers have been treated and, if so, obtain a copy of the guarantee. If there is no guarantee we recommend a precautionary inspection by a timber treatment specialist.

Purlin in roof space with worm.

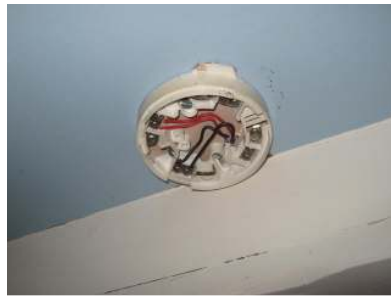
Smoke detectors are a valuable asset to a property and should be maintained in a working condition at all times. Mains wired detectors have been removed from the property but the wiring remains. You should reinstate this system for safety purposes. You should ask an electrician to inspect this installation.
